**Flood Control Project Maintenance
Levee Inspections**
LMA District Cover Sheet
Spring 2020 Levee Inspection Results

Reclamation District No. 2091 Chase

Spring 2020 Levee Inspection Results

Waterway			Bank	Unit Miles
Unit No. 01 San Joaquin River			Right	7.46
	Spring (March - May)	Summer (June - August)	(September - November) Fall	Winter (December - February)
Unit Maintenance Rating (Fall Only)				
Date of Inspection	3/26/2020 - 3/26/2020			
DWR Inspector	Corey Fujitani			
Accompanied By

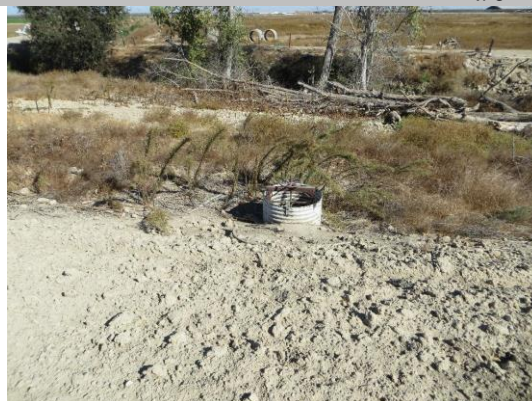
Photo 1 of 3 : UCIP_SP_2020_43207_38148.jpg

LM Start	0.08	Rating **	M	Issue No.	45	
LM End	0.08	Issue Type +	Ma	Location *		
Category	Supplemental			GPS Latitude/Longitude		
				Start		End
Item	DWR UCIP LMA Responsibility			37.541970 °		37.541970 °
				-121.093980 °		-121.093980 °
DWR ID	23155					
Comment Code						
Inspector Comment						
DS_ID:23155 FS_ID:43207 EP_NO: N/A Repair Type: Non-Urgent Crossing Status: Found UCIP Comments: 10/15/2013 Appears abandoned and if so should be done so properly. (W. Wylie - DWR UCIP) FIELD_STRUCT_DESC: *ABANDONED* 24-inch corrugated metal drainage pipe through the levee, 7.2 feet below the crown. Slide gate in a 36-inch corrugated metal pipe (CMP) riser on the waterside (WS) slope. [Additional Reference(s): DWR Levee Log, 1992. USACE San Joaquin O&M Manual 6, September 1961, (HLM 0.07), Drawing No. 07-04-1555, Sheets 1555/17 and 1555/55, (Station 906+85)]. FS Date: 1/29/2015 2:26:31 PM

Slide gate in 36-inch CMP riser on WS toe.

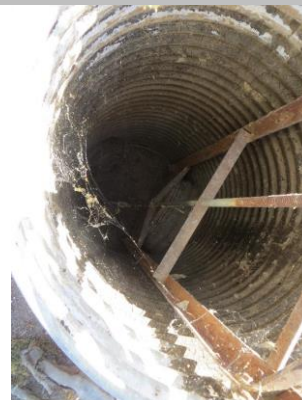
Photo 2 of 3 : UCIP_SP_2020_43207_38147.jpg

Slide gate in 36-inch CMP riser on WS toe.

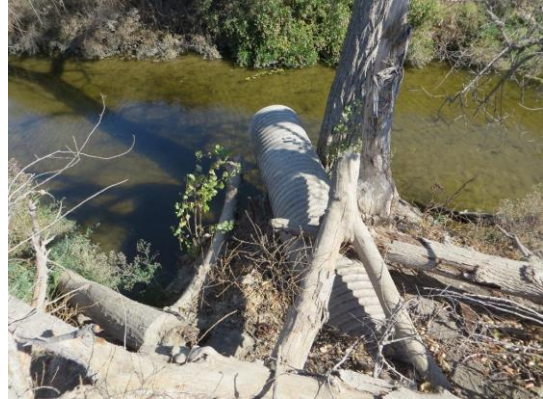
Photo 3 of 3 : UCIP_SP_2020_43207_38146.jpg

CMP stormdrain at outlet off WS toe.

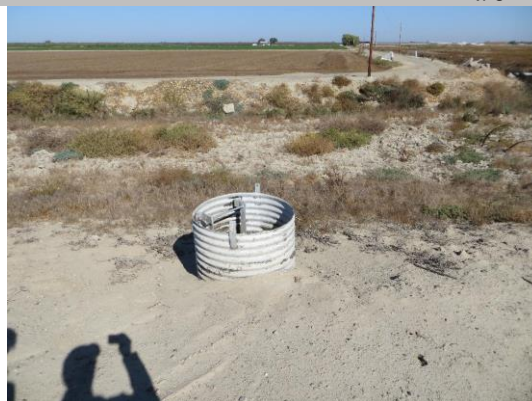
Photo 1 of 3 : UCIP_SP_2020_53094_38150.jpg

Comment Code						
Inspector Comment						
DS_ID:23156 FS_ID:53094 EP_NO: N/A Repair Type: Non-Urgent Crossing Status: Found UCIP Comments: 10/18/2018 Crossing remains abandoned. Unable to locate WS outlet due to dense vegetation. Crossing has been downgraded from Urgent to Non-Urgent. No integrity issues were observed along pipe alignment. LMA is still seeking proper abandonment or removal of this crossing. Crossing is part of the Deferred Maintenance Project (DMP) phase 1 inspection. No video inspection has been completed yet. (O. Magana - DWR UCIP) 11/18/2016 Same as last inspection this is a non-functional crossing with no visible inlet on LS or outlet on WS. The only appurtenance found at this location is a CMP riser with a missing cover located on the WS. This crossing remains Urgent since the pipe on the WS may still be opened. According to Mike Alves, this crossing is abandoned and the City of Modesto is working with CVFPB to authorize proper abandonment/removal. The City is working at finding funds to pay for proper abandonment/removal of all the drainage structures through this levee. (O. Magana - DWR UCIP)10/15/2013 Pipe open on WS and slide gate has been removed. Appears abandoned and should be done so properly. (W. Wylie - City of Modesto) FIELD_STRUCT_DESC: *ABANDONED* 24-inch corrugated metal drainage pipe through the levee, 9 feet below the crown. Slide gate in a corrugated metal pipe (CMP) riser located on the waterside (WS) slope. [Additional Reference(s): DWR Levee Log, 1992. USACE San Joaquin O&M Manual 6, September 1961, (HLM 0.10), Drawing No. 07-04-1555, Sheets 1555/17 and 1555/55, (Station 907+55)]. FS Date: 10/18/2018

36-inch CMP riser on WS slope.

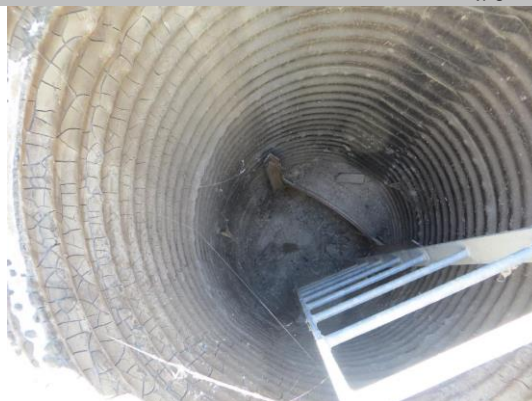
Photo 2 of 3 : UCIP_SP_2020_53094_38149.jpg

Slide gate missing from open end of pipe at WS slope.

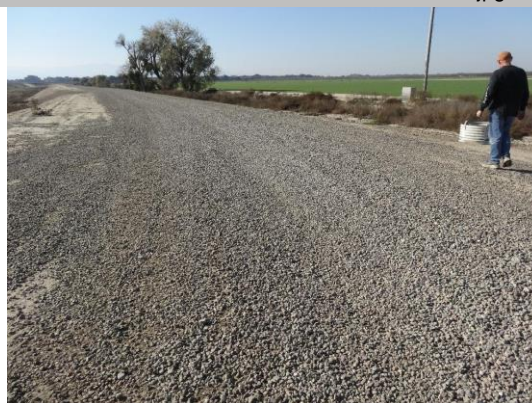
Photo 3 of 3 : UCIP_SP_2020_53094_76669.jpg

Overview of levee crown at pipe crossing.

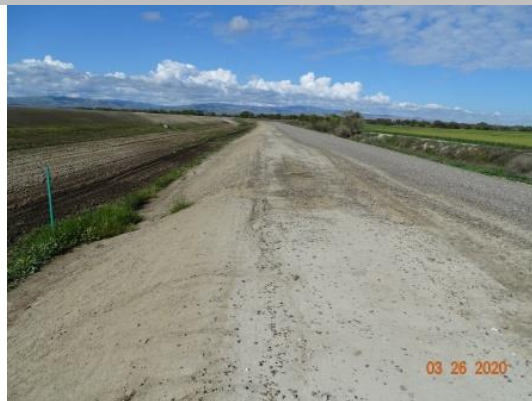
Photo 1 of 2 : SP_2020_RD2091_318_15_20200327_00030.jpg

LM Start	0.23	Rating **	A/W	Issue No.	15
LM End	0.23	Issue Type +	Ma	Location *	LS
Category	Earthen Levee			GPS Latitude/Longitude	
				Start	End
Item	Erosion / Bank Caving			37.541550 °	37.541550 °
				-121.096742 °	-121.096742 °
DWR ID	DWR_RD2091_01_s_2016_15				
Comment Code					
E1 : Note and monitor erosion site.					
Inspector Comment					
Caving on landward shoulder noted in 2017 possible collapsed pipe. Monitor for potential reoccurrence.

Looking west along the landside shoulder. (Spring 2020)

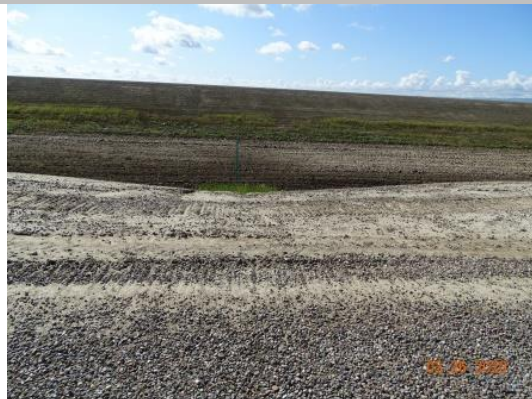
Photo 2 of 2 : SP_2020_RD2091_318_15_20200327_00031.jpg

Looking down the landside slope from the crown. (Spring 2020)

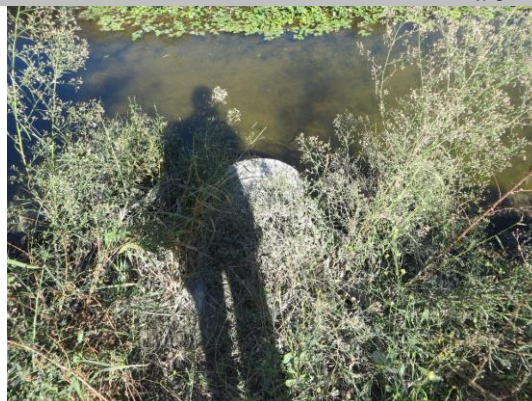
Photo 1 of 3 : UCIP_SP_2020_53431_38156.jpg

DS_ID:23158
FS_ID:53431
EP_NO: N/A
Repair Type: Non-Urgent
Crossing Status: Found
UCIP Comments: 10/18/2018 Crossing remains abandoned. Unable to locate WS outlet due to dense vegetation. Crossing has been downgraded from Urgent to Non-Urgent, no integrity issues were observed along the pipe alignment. LMA is still seeking proper abandonment or removal of this crossing. This crossing is part of the Deferred Maintenance Project (DMP) phase 1 inspection. No video inspection has been completed yet. (O. Magana - DWR UCIP)
11/18/2016 Same as last inspection. This crossing remains Urgent due to the flap gate still missing from the WS toe. According to Mike Alves, this crossing is an abandoned line and the City of Modesto is working with CVFPB to authorize proper abandonment/removal. The City is working at finding funds to pay for proper abandonment/removal of all the drainage structures through this levee. (O. Magana - DWR UCIP)

10/15/2013 Flap gate has fallen off at WS toe. Appears abandoned and if so should be done so properly. (W. Wylie - DWR UCIP)
FIELD_STRUCT_DESC: *ABANDONED* 24-inch corrugated metal drainage pipe through the levee, 10 feet below the crown. Flap gate on the waterside (WS) end. Drain opening is located approximately 15 feet off the landside (LS) toe. [Additional Reference(s): DWR Levee Log, 1992. USACE San Joaquin O&M Manual 6, September 1961, (HLM 0.23), Drawing No. 07-04-1555, Sheets 1555/17 and 1555/55, (Station 915+00)].
FS Date: 10/18/2018

Pipe visible in canal on WS toe.

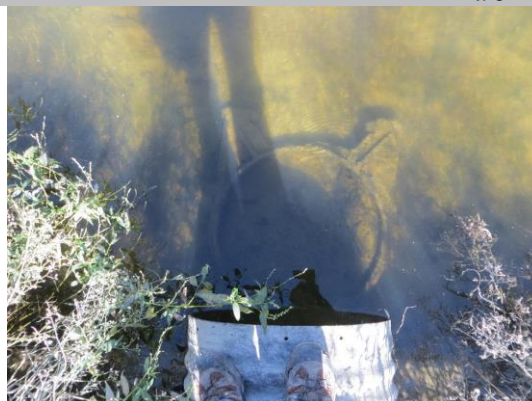
Photo 2 of 3 : UCIP_SP_2020_53431_38155.jpg

Flapgate has fallen off at WS toe.

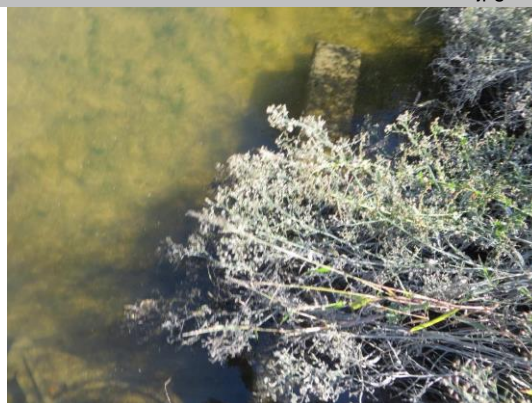
Photo 3 of 3 : UCIP_SP_2020_53431_38154.jpg

Concrete headwall under pipe at WS toe.

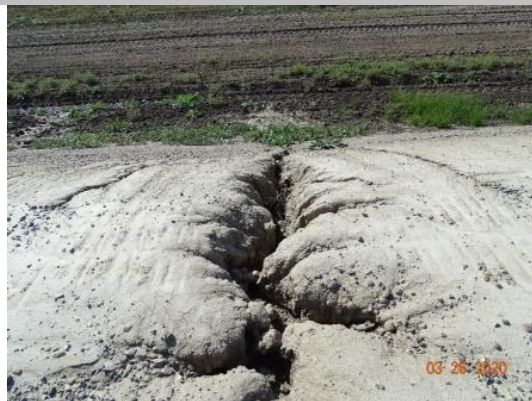
Photo 1 of 2 : SP_2020_RD2091_318_16_20200327_00034.jpg

LM Start	0.25	Rating **	M	Issue No.	16
LM End	0.28	Issue Type +	Ma	Location *	LS
Category	Earthen Levee			GPS Latitude/Longitude	
				Start	End
Item	Erosion / Bank Caving			37.541492 °	37.541408 °
				-121.097052 °	-121.097453 °
DWR ID	DWR_RD2091_01_s_2016_16				
Comment Code					
E1 : Note and monitor erosion site.					
Inspector Comment					
Several sites of rill erosion and possible rodent holes along landward shoulder and slope.

Looking down the landside slope at representative rill. (Spring 2020)

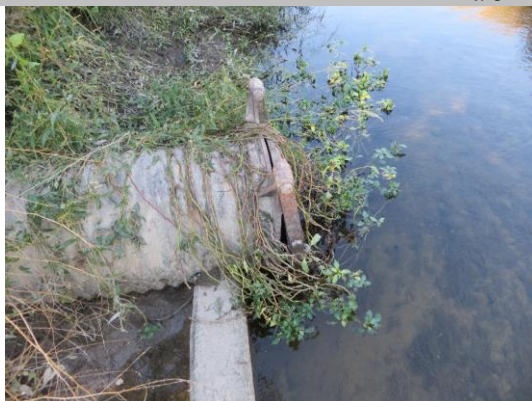
Photo 2 of 3 : UCIP_SP_2020_51639_38157.jpg

24-inch CMP on concrete headwall with flapgate on WS toe.

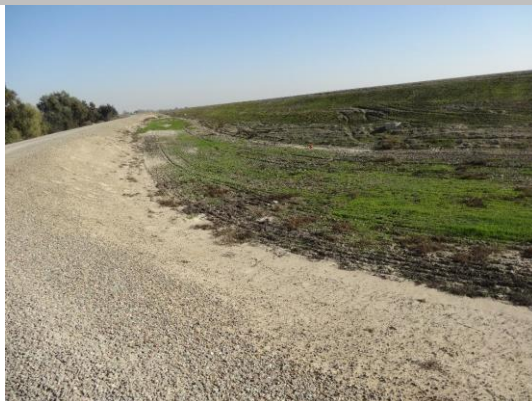
Photo 3 of 3 : UCIP_SP_2020_51639_76677.jpg

View of LS.

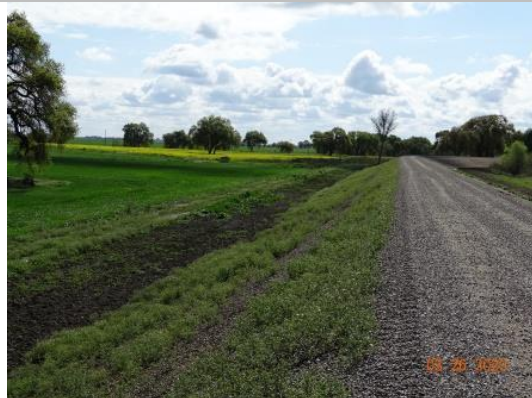
Photo 1 of 1 : SP_2020_RD2091_318_11_20200327_00036.jpg

LM Start	3.31	Rating **	M	Issue No.	11
LM End	3.44	Issue Type +	Ma	Location *	LS
Category	Earthen Levee			GPS Latitude/Longitude	
				Start	End
Item	Vegetation			37.512762 °	37.511583 °
				-121.089860 °	-121.087920 °
DWR ID	DWR_RD2091_01_s_2020_11				
Comment Code					
V1 : Control annual grass and weeds on the levee slopes and easements.					
Inspector Comment

View of landside slope looking upstream. (Spring 2020)

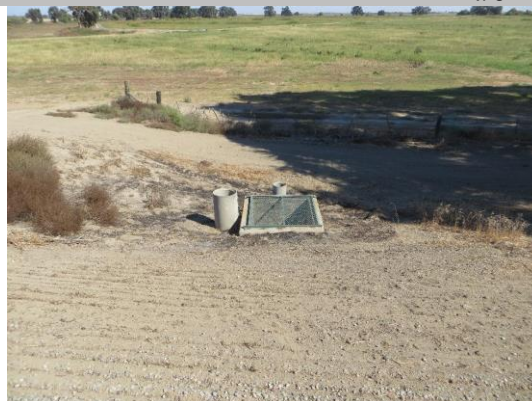
Photo 1 of 3 : UCIP_SP_2020_43209_38211.jpg

LM Start	4.59	Rating **	M	Issue No.	49	
LM End	4.59	Issue Type +	En	Location *		
Category	Supplemental			GPS Latitude/Longitude		
				Start	End	
Item	DWR UCIP Field Study			37.497390 °	37.497390 °	
				-121.080370 °	-121.080370 °	
DWR ID	23165					
Comment Code						
Inspector Comment						
DS_ID:23165 FS_ID:43209 EP_NO: N/A Repair Type: Non-Urgent Crossing Status: Found UCIP Comments: 10/15/2013 Appears abandoned and if so should be done so properly. (P. Amatya - DWR UCIP) FIELD_STRUCT_DESC: 36-inch corrugated metal irrigation pipe through the levee, 15 feet below the crown. Abandoned concrete inlet box on the waterside (WS) slope of the levee. 6-foot by 5-foot concrete distribution box at the landside (LS) toe. [Additional Reference(s): DWR Levee Log, 1992. USACE San Joaquin O&M Manual 6, September 1961, (HLM 4.67), 30-inch pipe listed]. FS Date: 1/29/2015 2:27:42 PM

Distribution box on LS toe.

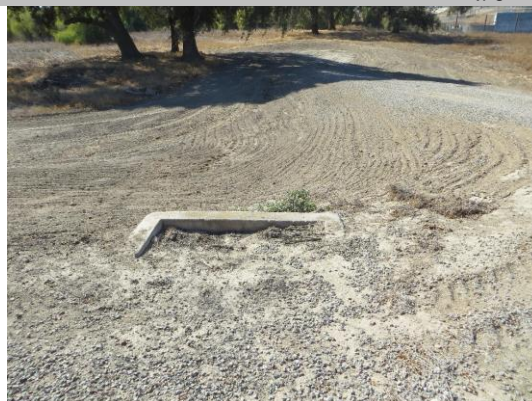
Photo 3 of 3 : UCIP_SP_2020_43209_38209.jpg

Abandoned concrete box on WS slope.

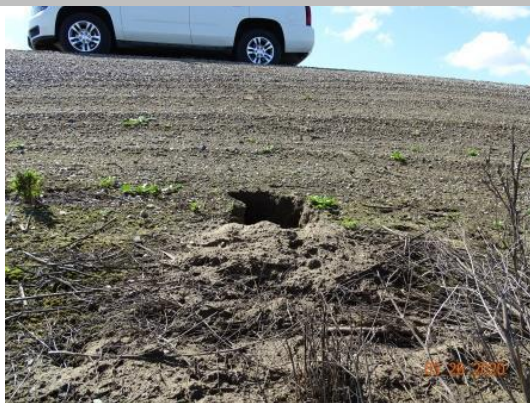
Photo 1 of 2 : SP_2020_RD2091_318_14_20200327_00038.jpg

LM Start	6.07	Rating **	M	Issue No.	14
LM End	6.07	Issue Type +	Ma	Location *	LS
Category	Earthen Levee			GPS Latitude/Longitude	
				Start	End
Item	Animal Control			37.486852 °	37.486852 °
				-121.060915 °	-121.060915 °
DWR ID	DWR_RD2091_01_s_2020_14				
Comment Code					
A3 : No rodents visible, but rodent burrows visible; need to backfill and compact or grout burrows.					
Inspector Comment

View of animal burrow from landside toe. (Spring 2020)

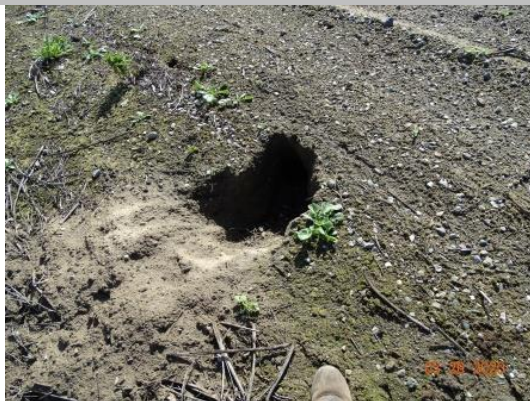
Photo 2 of 2 : SP_2020_RD2091_318_14_20200327_00037.jpg

View of animal burrow in landside slope. (Spring 2020)

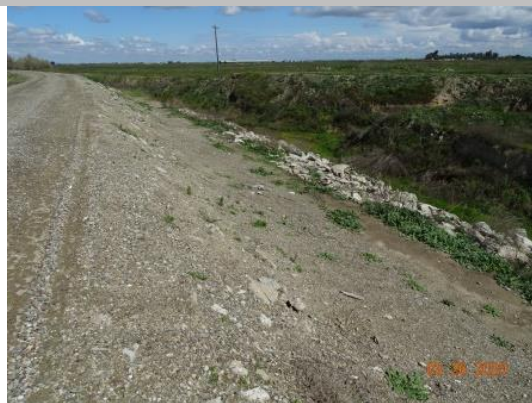
Photo 1 of 3 : SP_2020_RD2091_318_8_20200327_00039.jpg

LM Start	7.42	Rating **	U	Issue No.	8
LM End	7.45	Issue Type +	Ma	Location *	LS
Category	Earthen Levee			GPS Latitude/Longitude	
				Start	End
Item	Erosion / Bank Caving			37.479308 °	37.478998 °
				-121.044708 °	-121.044660 °
DWR ID	DWR_RD2091_01_s_2017_8				
Comment Code					
E2 : Schedule repair of erosion site prior to the next inspection.					
Inspector Comment					
Repaired area with concrete containing rebar. Need to remove rebar.

Looking east at repaired site on waterward slope and toe. (Spring 2020)

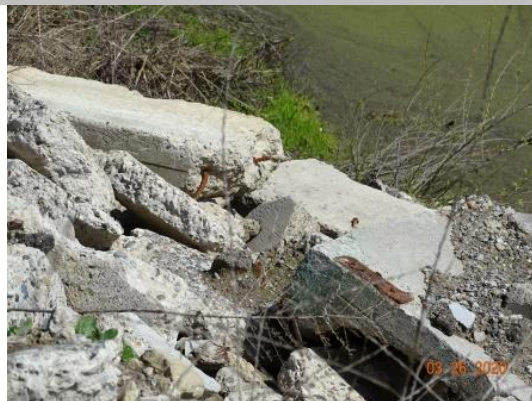
Photo 2 of 3 : SP_2020_RD2091_318_8_20200327_00045.jpg

View of rebar and other steel in the concrete rubble along the landside toe. (Spring 2020)

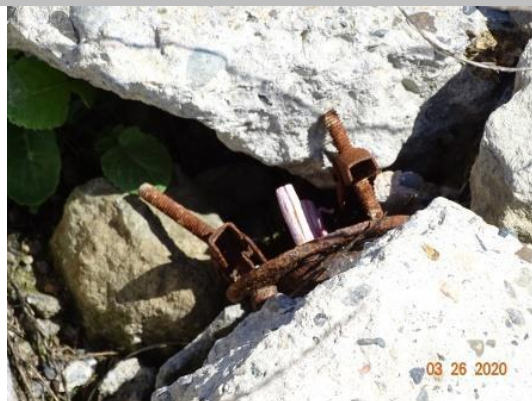
Photo 3 of 3 : SP_2020_RD2091_318_8_20200327_00042.jpg

View of rebar within the concrete rubble. (Spring 2020)

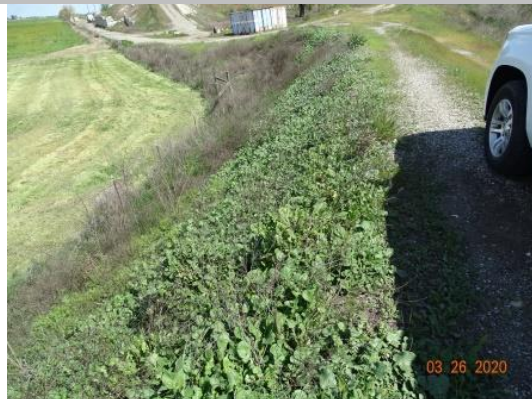
Photo 1 of 1 : SP_2020_RD2091_319_2_20200327_00006.jpg

LM Start	0.01	Rating **	M	Issue No.	2
LM End	0.04	Issue Type +	Ma	Location *	LS
Category	Earthen Levee			GPS Latitude/Longitude	
				Start	End
Item	Vegetation			37.482318 °	37.482685 °
				-121.051350 °	-121.050975 °
DWR ID	DWR_RD2091_02_f_2019_2				
Comment Code					
V1 : Control annual grass and weeds on the levee slopes and easements.					
Inspector Comment

View of the landside slope. (Spring 2020)

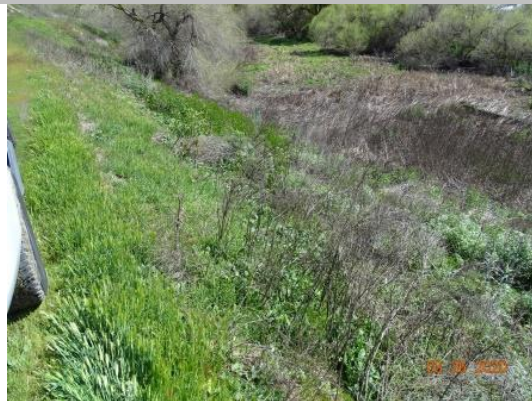
Photo 1 of 1 : SP_2020_RD2091_319_3_20200327_00007.jpg

LM Start	0.02	Rating **	U	Issue No.	3
LM End	0.04	Issue Type +	Ma	Location *	WS
Category	Earthen Levee			GPS Latitude/Longitude	
				Start	End
Item	Vegetation			37.482384 °	37.482685 °
				-121.051279 °	-121.050975 °
DWR ID	DWR_RD2091_02_f _ 2019_3				
Comment Code					
V1 : Control annual grass and weeds on the levee slopes and easements.					
Inspector Comment

View of the waterside slope. (Spring 2020)

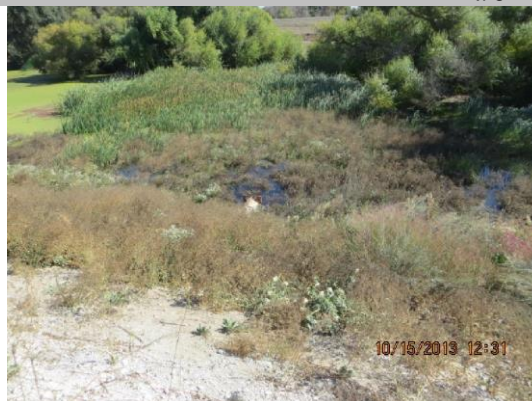
Photo 1 of 3 : UCIP_SP_2020_51390_38216.jpg

DS_ID:23175
FS_ID:51390
EP_NO: N/A
Repair Type: Non-Urgent
Crossing Status: Found
UCIP Comments: 11/18/2016 Same as last inspection. This is a non-functional crossing with flap gate in the closed position. This crossing has been downgraded from Urgent to Non-Urgent -- no integrity issues were observed on the levee crown or slopes. According to Mike A. this crossing is abandoned and the City of Modesto is working with CVFPB to authorize proper abandonment/removal. The City is working at finding funds to pay for proper abandonment/removal of all the drainage structures through this levee. (O. Magana - DWR UCIP)10/15/2013
Flap gate rusted in-place and does not function. In closed position. (W. Wylie - DWR UCIP)
FIELD_STRUCT_DESC: 24-inch corrugated metal drainage pipe through the levee, 16.4 feet below the crown. Flap gate on the waterside (WS) toe. [Additional Reference(s): DWR Levee Log, 1992].
FS Date: 11/18/2016

24-inch CMP with flapgate visible on WS toe.

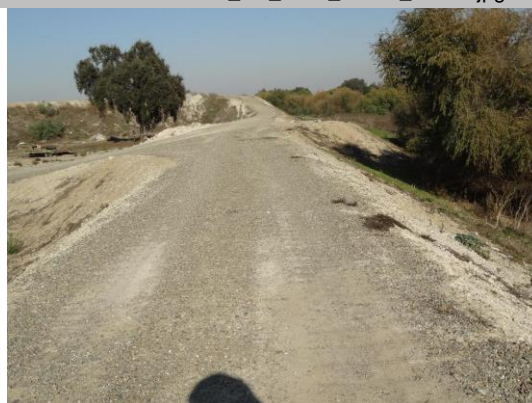
Photo 2 of 3 : UCIP_SP_2020_51390_76689.jpg

Overview photo of levee crown at crossing.

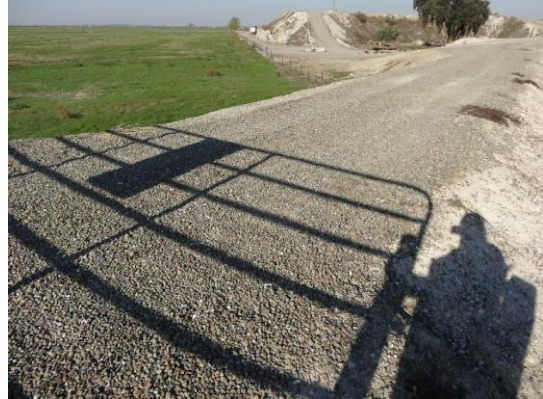
Photo 3 of 3 : UCIP_SP_2020_51390_76686.jpg

Overview of levee crown at crossing and at a distance there is a shooting range.
